**SIZZLING SHOWCASE:
TEMPERATURE STUDY OF THE ADELL McMILLAN GALLERY
AT THE UNIVERSITY OF OREGON ERB MEMORIAL UNION**

ABSTRACT

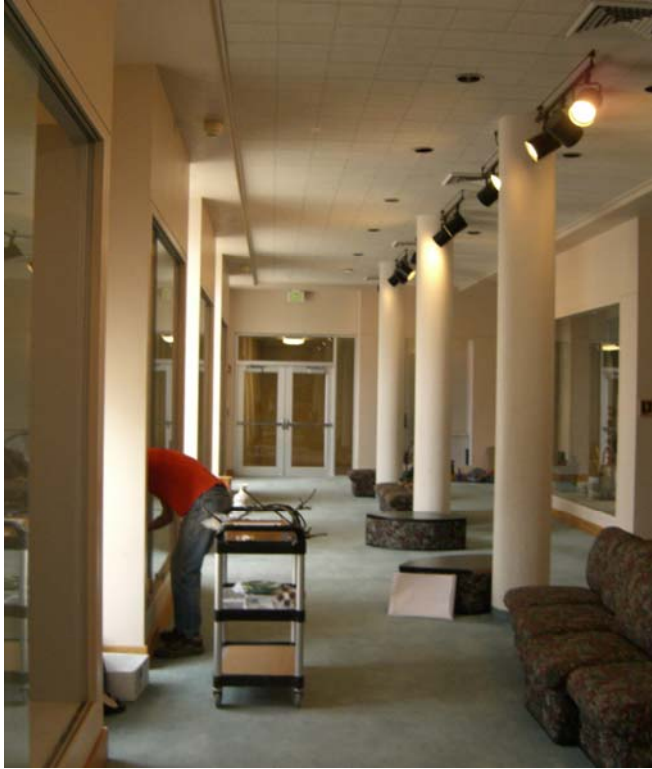
Fig. 2 A view down the warmer west side of the gallery, beneath which the room's radiant heating system is located.

was setting up the gallery and mentioned the warmth of the floor. This inspired further examination on our part, and we learned that the gallery is heated by a radiant under-floor system, located only under the western half of the room, whose heat output is determined based upon the outdoor air temperature (set point). Our attention was also drawn to the effect that solar gain during from the row of windows along the gallery's western wall could have during afternoons.

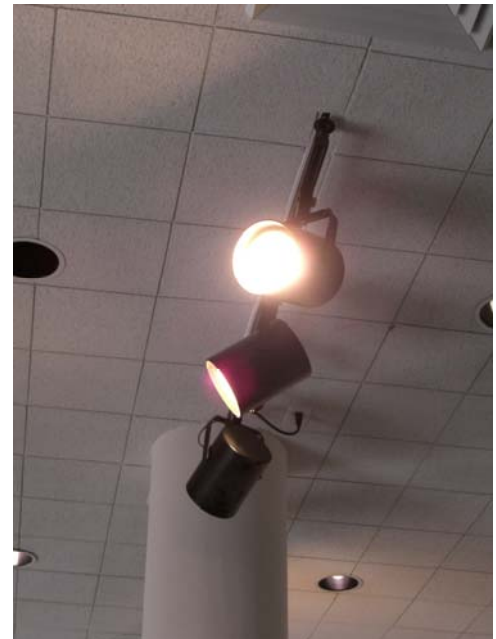
Fig. 3 The gallery display lights.

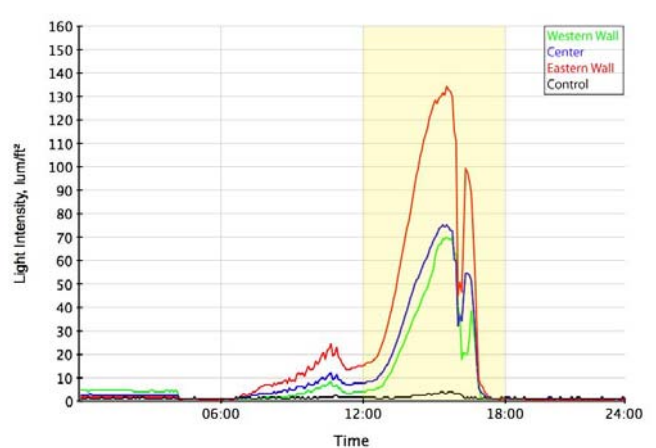
Fig. 8 Light intensity measurements—Wednesday 5 March (Lights off, mostly sunny) (afternoon peak period shaded)

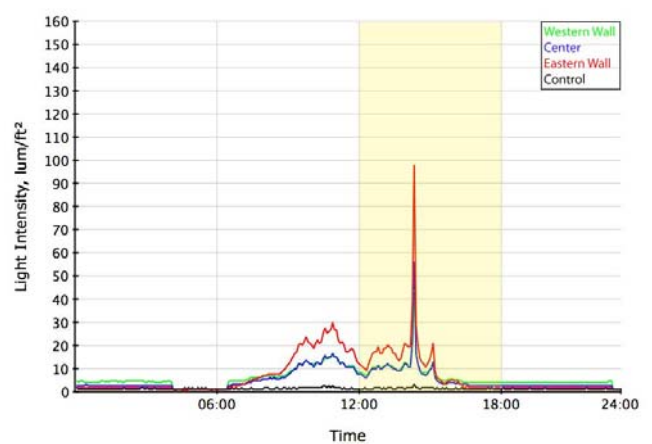
Fig. 12 Light intensity measurements—Friday 7 March (Lights on, mostly cloudy) (afternoon peak period shaded)

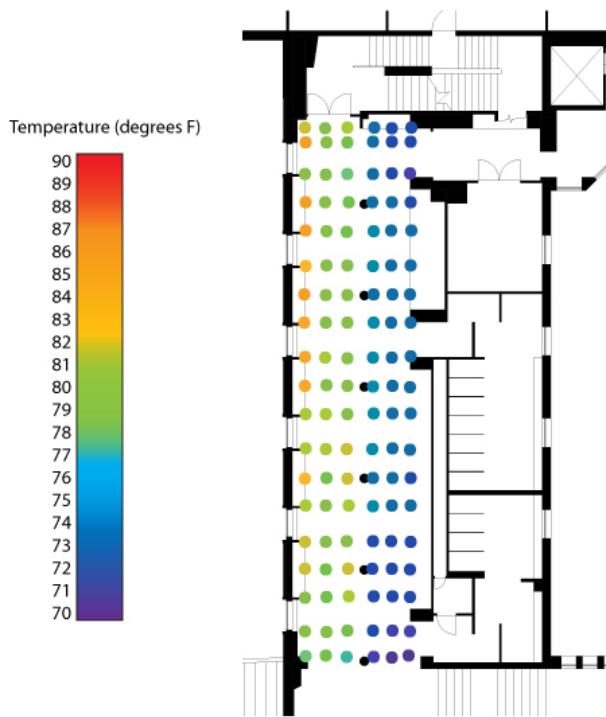
Fig. 13 Floor surface temperature map—Thursday afternoon 6 March (Lights off, somewhat cloudy)

- To do this, we established a grid whose north-south coordinates were based on the columns and the edges of windows and whose east-west coordinates were 3 feet, 6 feet, 10 feet, and 12 feet from the western edge of the room as well as this and the eastern edge (see figures 13 and 14 for locations of the coordinates on this grid).

The maps in figures 13 and 14 below show the gradient of surface temperatures on the floor of the gallery. While our air temperature data show that the air tends to be slightly warmer on the west side of the room, the data in these temperature maps show clearly that the *floor* of the west side of the room is much warmer than that of the east side. The surface temperature of the floor on the two sides of the room differed by as much as 18° F. This temperature discrepancy is almost surely due to the fact that the radiant heating system runs only under the western half of the floor, its eastern boundary being the row of columns. The floor temperatures were generally slightly higher for Friday 7 March, when the display lights were *on*, suggesting the lights have a small impact on the floor temperature. Still, the overwhelming pattern of floor temperatures appears to be due to the location of the under-floor radiant heating lines.

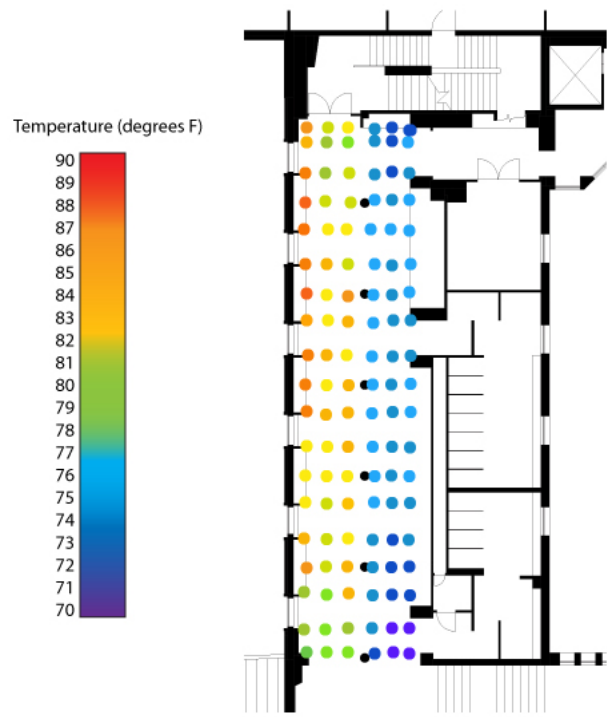
Fig. 14 Floor surface temperature map—Friday afternoon 7 March (Lights on, mostly cloudy)

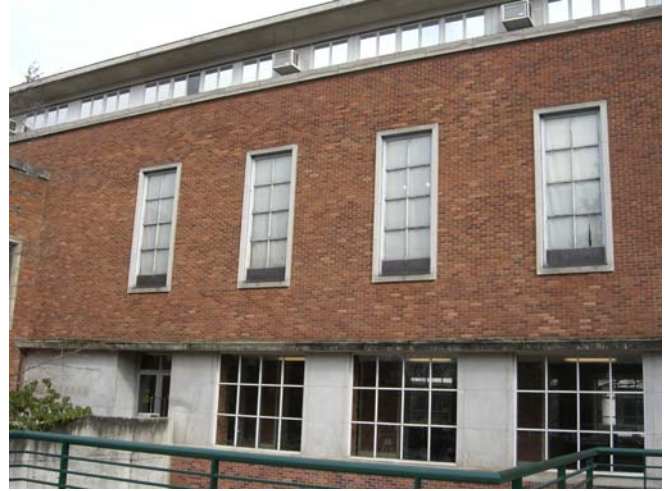
Fig. 15 Exterior shading devices may be able to improve the thermal performance of the McMillan gallery.

In addition, our investigation made evident the value sunlight can have as a heat source. The afternoon solar gain had a significant impact on the temperature in the gallery. Thus, combined with a heating system that takes solar gain into account, even in spaces not specifically designed to be passively heated, solar gain can be used to advantage, reducing the energy use required by the heating system. In the McMillan gallery, the previously discussed changes in the heating system could allow the space to take advantage of solar gain for heating during the heating season. When this sunlight is not desired, exterior shading devices and adjustable interior shades (assuming the problem of vandalism can be overcome) could be used. Also, even with the heating system as it currently exists,

shades could still be quite useful in blocking solar gain during the afternoon, which right now merely increases the temperature of the room to possibly uncomfortable levels.
