WILL THE REAL R-VALUE PLEASE STAND UP

Joe J. Johnson
Department of Architecture
University of Oregon
Eugene, Oregon
jjohnson@uoregon.edu

This paper describes an approach to determine actual R-values in existing wood framed wall construction as compared to component calculated and prescribed R-values.

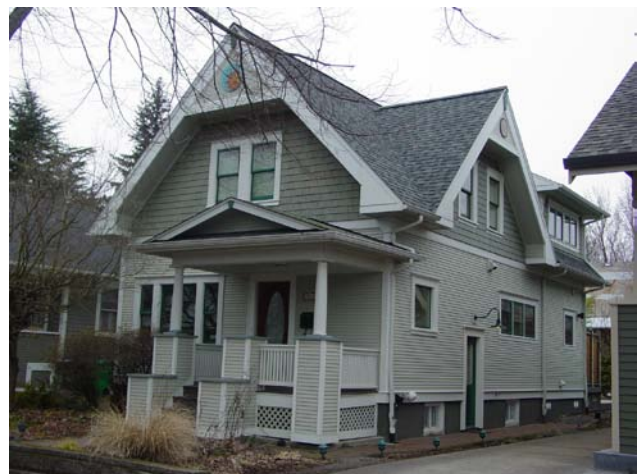
Fig. 1: Southeast Elevation

The focus of the study was a home built in 1913 in Portland, Oregon. The home, a four-square bungalow, was recently renovated in 2004-2005 (Fig. 1). The two story structure, approximately 1900 square feet, has three bedrooms and 2-1/2 baths. It included a partial basement set five feet below grade. The wood framed structure has nominal 2x4 studs (balloon framing) in the original building section and 2x6 studs (platform framing) in the newer addition. Both cellulose and fiberglass insulation have been installed in the exterior walls.

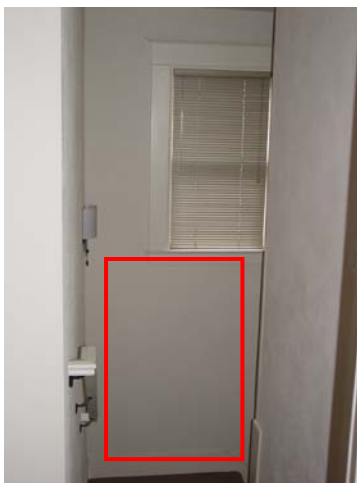
Fig. 2: Second Floor Stair Landing East Wall-1

Step 1 - Select Wall Test Areas: Four original wall areas were tested (Fig. 2 - 5) to provide a minimum and diverse sample study size. All of these areas have actual 2x4 (two inch by four inch) stud construction. Three areas were insulated with mechanically blown-in cellulose, and the fourth area was hand applied fiberglass batt insulation (Fig. 4).

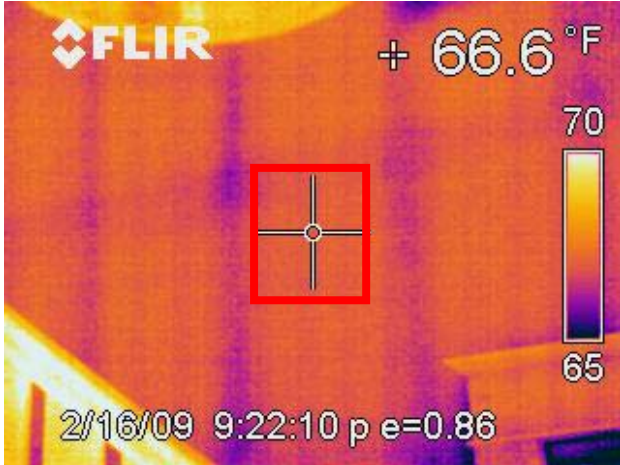
Step 3 - Record Thermal Images: Thermal image readings were taken at the four wall locations, both on the interior (Fig. 6) and exterior surfaces (Fig. 7).

Fig. 6: Typical Interior Surface Temperature Location

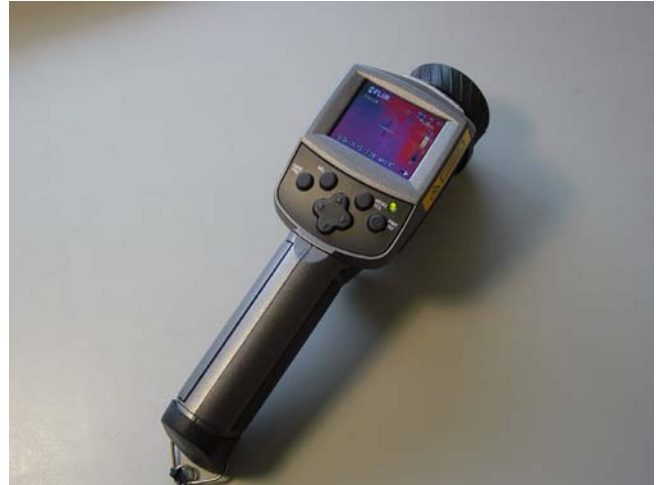
Equipment: A FLIR BX-320 Infrared Camera (Fig. 8) was used to provide thermal imaging and surface temperature readings. In addition, FLIR's ThermoCAM Quickview software was used to determine spot temperature readings at other wall locations. Once the initial thermal images were processed, the software interpolated temperature readings

Fig. 8: FLIR BX-320 Infrared Camera

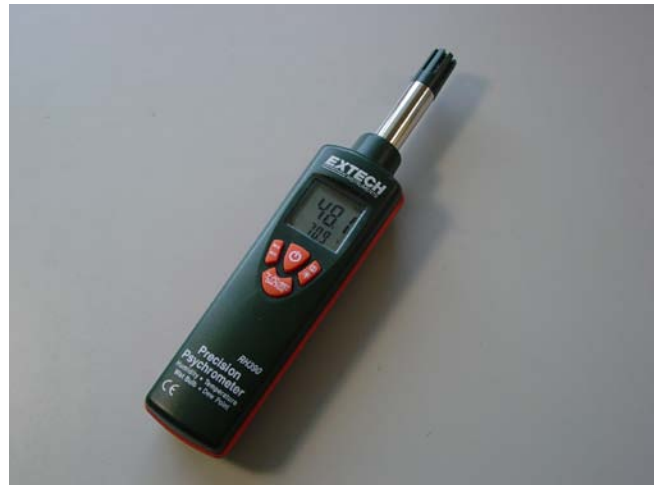
Average interior ambient air temperatures were recorded by the infrared camera and EXTECH RH390 Psychrometer (Figure 9).

Fig. 9: EXTECH RH390 Psychrometer

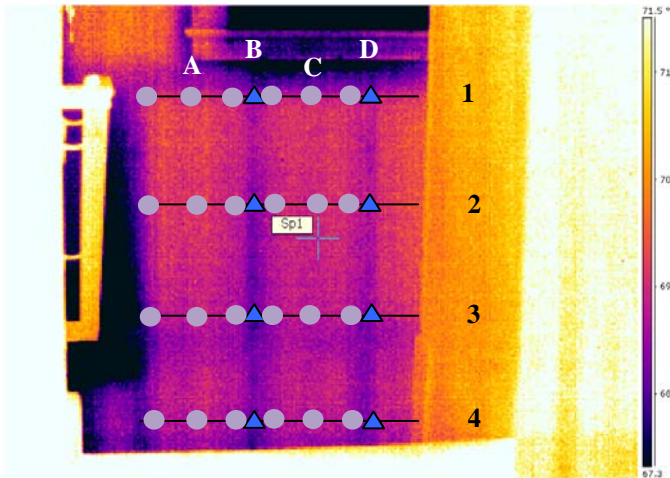
4.3 - Actual Wall R-value: To begin the process of determining Actual Wall R-value, thermal infrared images were first taken at all four wall locations as described in Section 3 above. Temperature spot readings were taken (Fig. 14) and recorded (TABLE A) for framing and cavity areas.

Fig. 14: Temperature Reading Locations Wall-1

Using the surface temperatures for stud and cavity areas in Table A below for Wall-1, the average stud and cavity temperatures were calculated at 66.6 °F and 67.2 °F respectively.

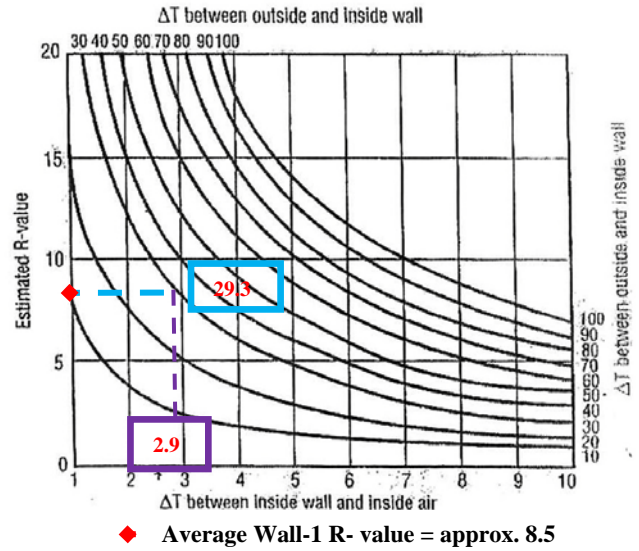
To complete the process, using the data from Wall-1 in Table B and information provided by the Infrared Training Center (ITC) and the National Comfort Institute, the actual R-value was determined using the graph in Fig. 15. (1, 2)

Fig. 15: Average R-value Interpolation for Wall-1 using indoor air, and exterior and interior wall surface temperatures. (1)(2)

- D. Accurate inside and surface temperature information is critical to this analysis. The increase or decrease of tenth of degree temperature readings during the analysis can have a profound effect on the graph in Fig. 15 and the resultant actual R-value. This is why it is imperative that all interior air and surface temperatures be recorded carefully. One of the important factors in recording accurate field temperatures is making sure that the infrared camera is calibrated on site and to the surrounding conditions prior to recording any infrared readings.

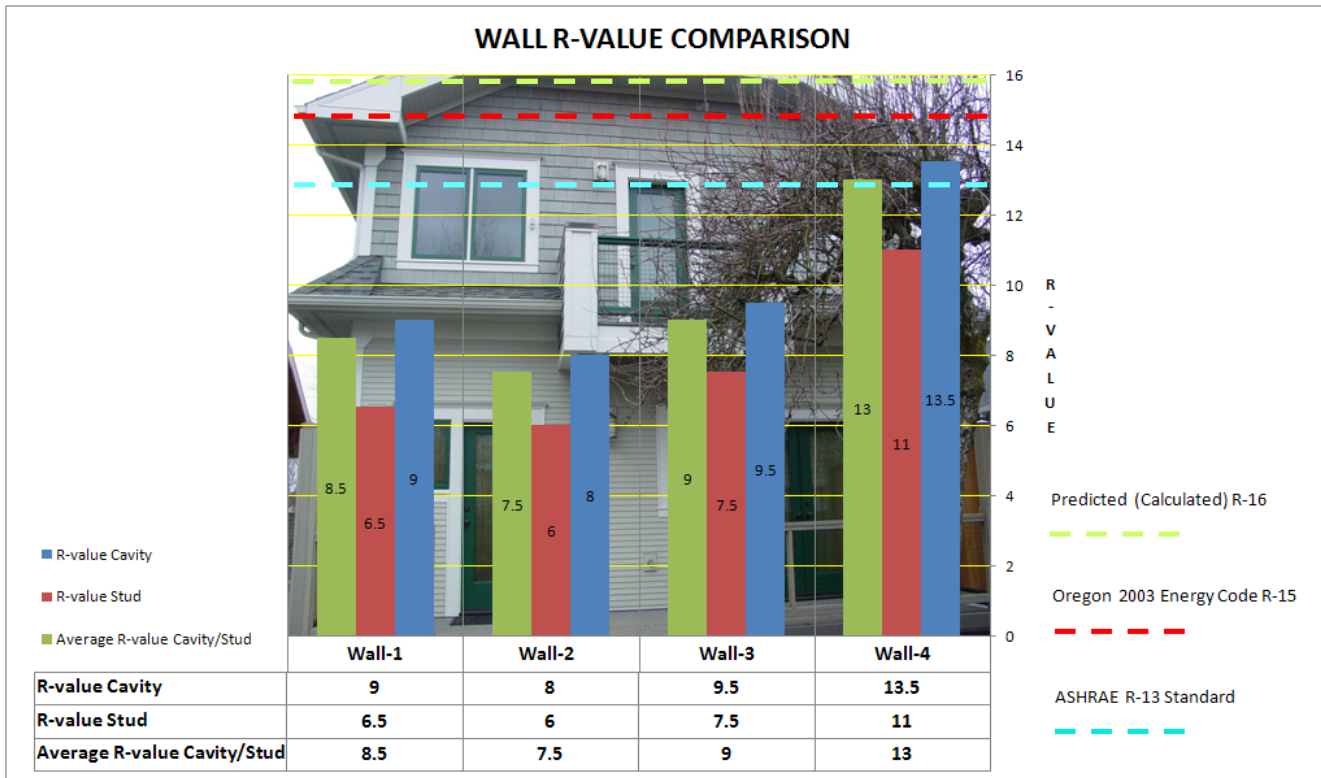
The remaining wall areas were also graphed and the information was used to establish an actual average R-value comparison chart (Fig 16). The chart includes a breakdown of each wall's associated stud and cavity

R-values. In addition, dashed horizontal reference lines are used to compare the actual R-values with predicted (R-16), Oregon Building Code (R-15), and ASHRAE (R-13) R-values.

Fig. 16: Wall R-value Comparison Chart

Based on Fig. 16 above, the average whole wall R-value for all four walls was R-9.5. The average R-values ranged from a low of R-7.5 to a high of R-13. The difference in the average R-value is 27% to 41% lower as compare to the three R-value benchmarks.
