HUMIDITY CONTROL IN A BASEMENT ART VAULT

This work was completed as part of a course assignment for Environmental Control Systems I in the winter of 2011.

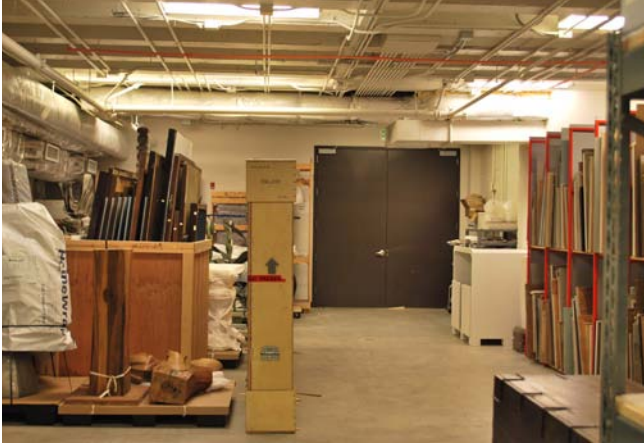
Fig. 5: ZONE 1 - front storage room, facing main vault entry on north wall

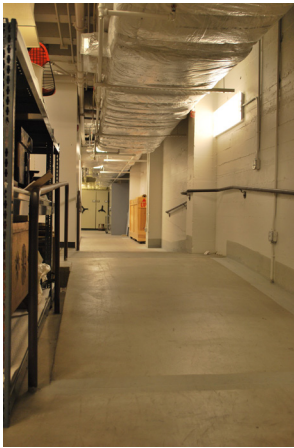
Fig. 6: ZONE 2 - compressed hallway

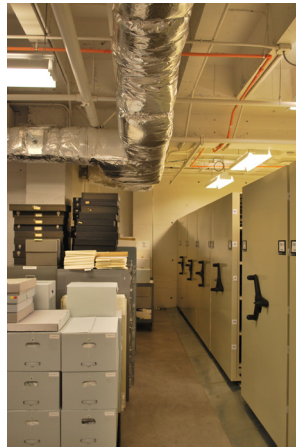
Fig. 7: ZONE 3 - back storage room

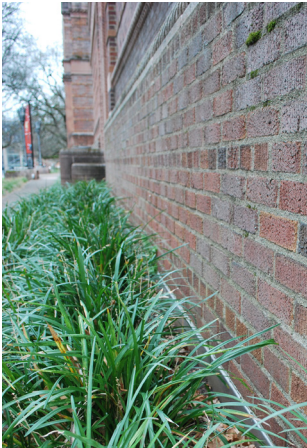
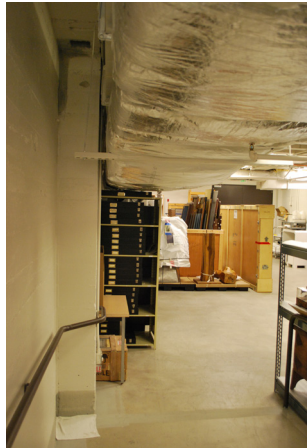
Fig. 8 & 9: The west exterior CMU wall.

b) There is one exterior wall that all three zones share. This is a CMU wall that runs along the west side of the building. Since we believe that the CMU wall is not functioning as a moisture barrier and that humidity will be higher closer to this wall, we will place one HOBO on this wall in each of the three zones. The remaining HOBOS will be placed on

The data we recorded throughout the week indicated that fluctuations within any given 24 hour period and throughout the space as a whole are less than ideal for storing art. The data also indicates that one of the factors influencing conditions within the vault is the non-insulated, exterior masonry wall on the west edge of the space. This suggests that a possible solution to difficulties maintaining consistent and appropriate RH and temperature levels within the vault could be mitigated with changes to the exterior wall such as the addition of insulation and a vapor barrier.
