**SPENCER BUTTE
RECREATIONAL IMPACT STUDY**

Report Prepared by
Environmental Studies Service Learning Program
University of Oregon

July 19, 2002

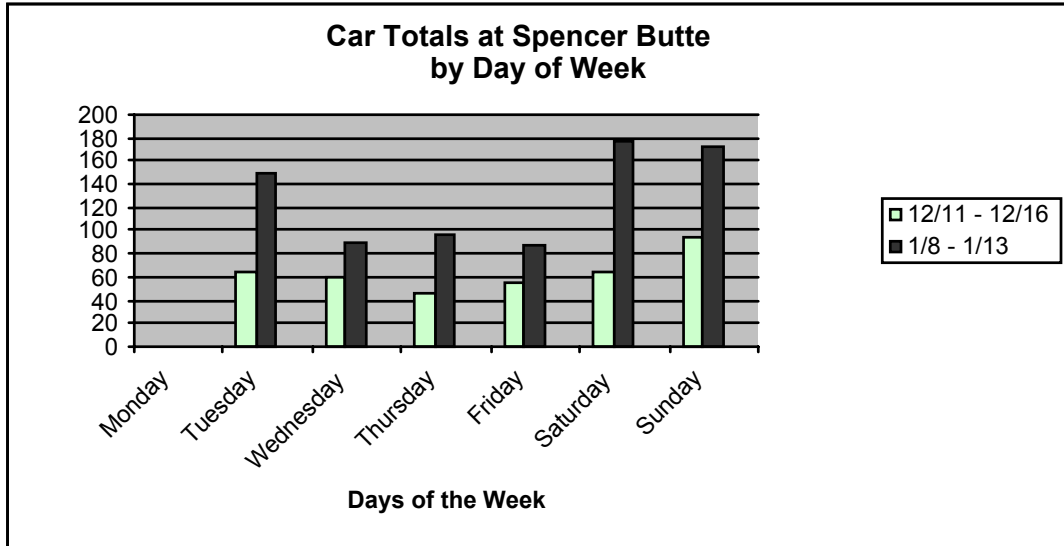
The graph entitled, “*Car Totals at Spencer Butte by Day of the Week,*” indicates that weekend usage is higher than on weekday visits. It is also very noticeable, that the data from 1/8 – 1/13 has much higher numbers than the data from 12/11 – 12/16. Over 700 more cars came during the busier week. Weather data shows that there was not a significant difference between the two weeks in terms of temperature, rain and other conditions. Possibly this large difference in data is a result of “Winter Break” at the University of Oregon, when thousands of students vacate Eugene to go home for the holidays.

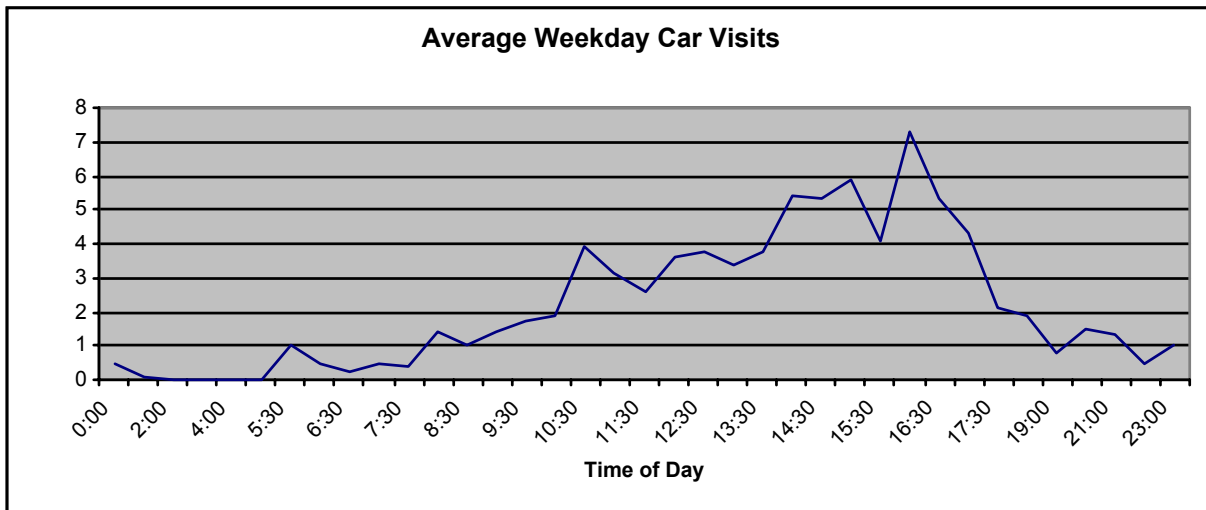
From the collected data, patterns of visitor use emerged for both weekdays and weekend days. An average weekday at Spencer Butte is shown on the graph entitled, “*Average weekday Car Visits.*” First, there is a small “morning crowd” that comes in from 5:00 – 7:30 on weekdays.

Then as the day progresses, visitor use increases at 11:00. The peak of visitors comes usually during the late afternoon, often before the sunset.

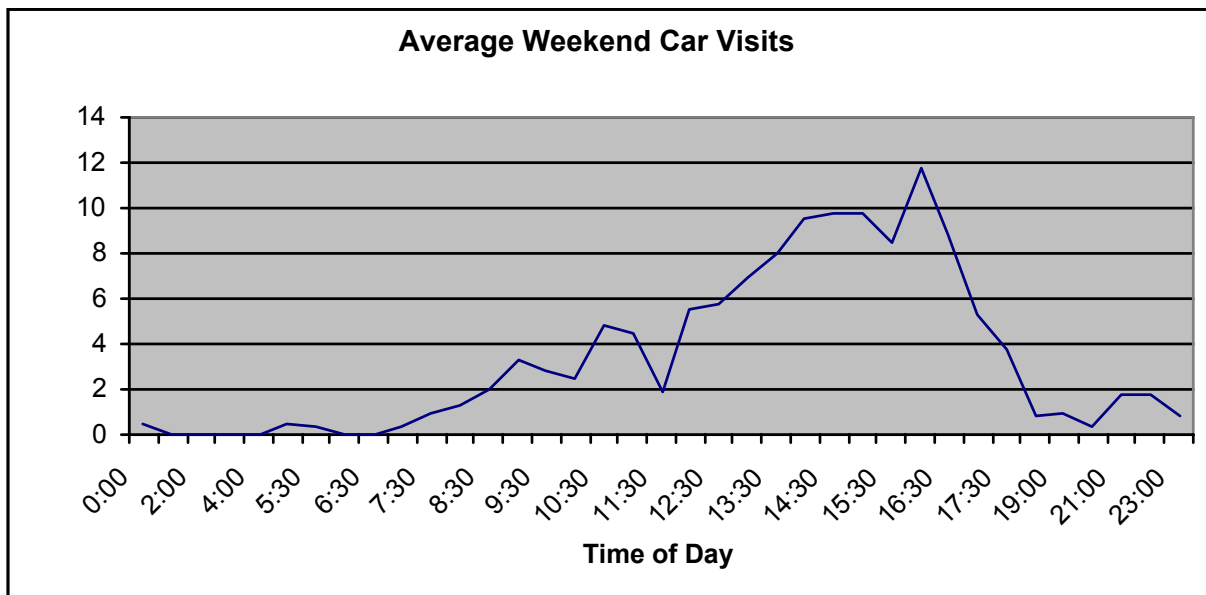
An average weekend at Spencer Butte is represented by the graph entitled, “Average Weekend Car Visits.” Weekend days during the traffic survey typically did not have a “morning crowd.” Here, once again, visitor use picked up around 11:00 and peaked somewhere in the late afternoon.

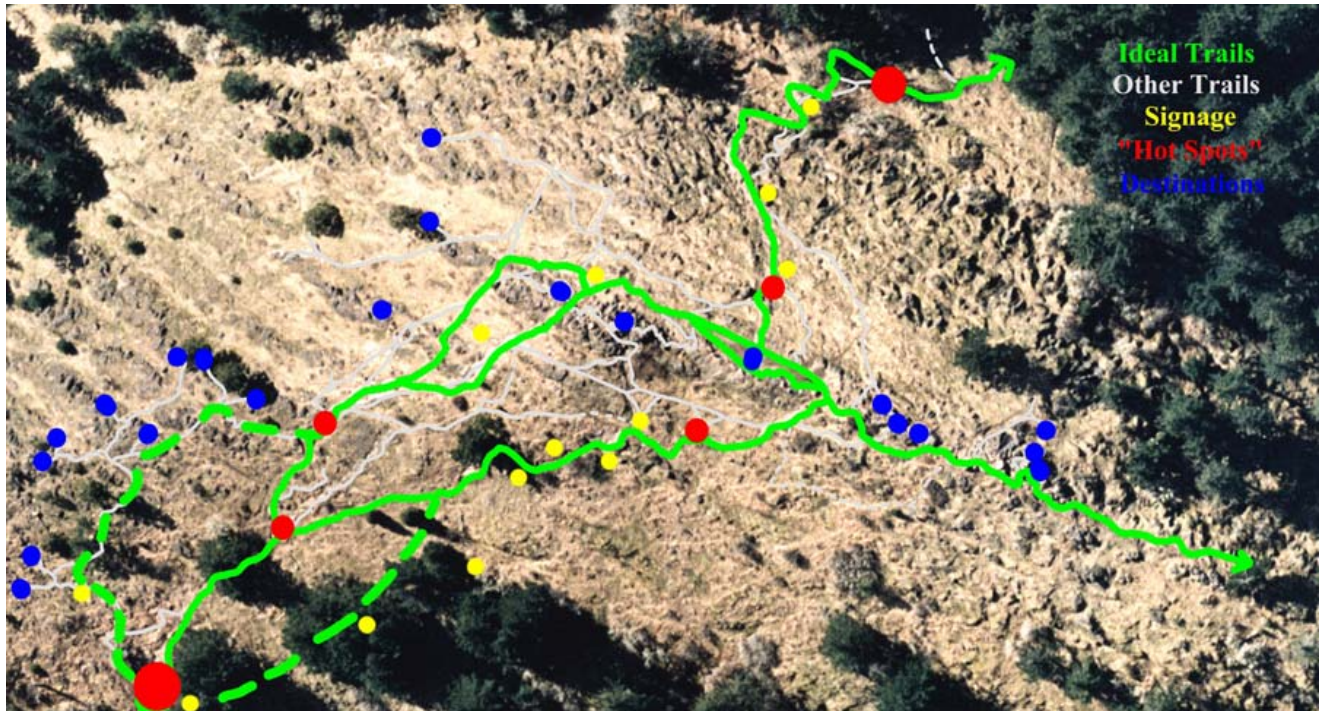
This map includes the documented destinations hikers use, the identified “hot spots”, all existing trails, as well as locations for proposed signage.

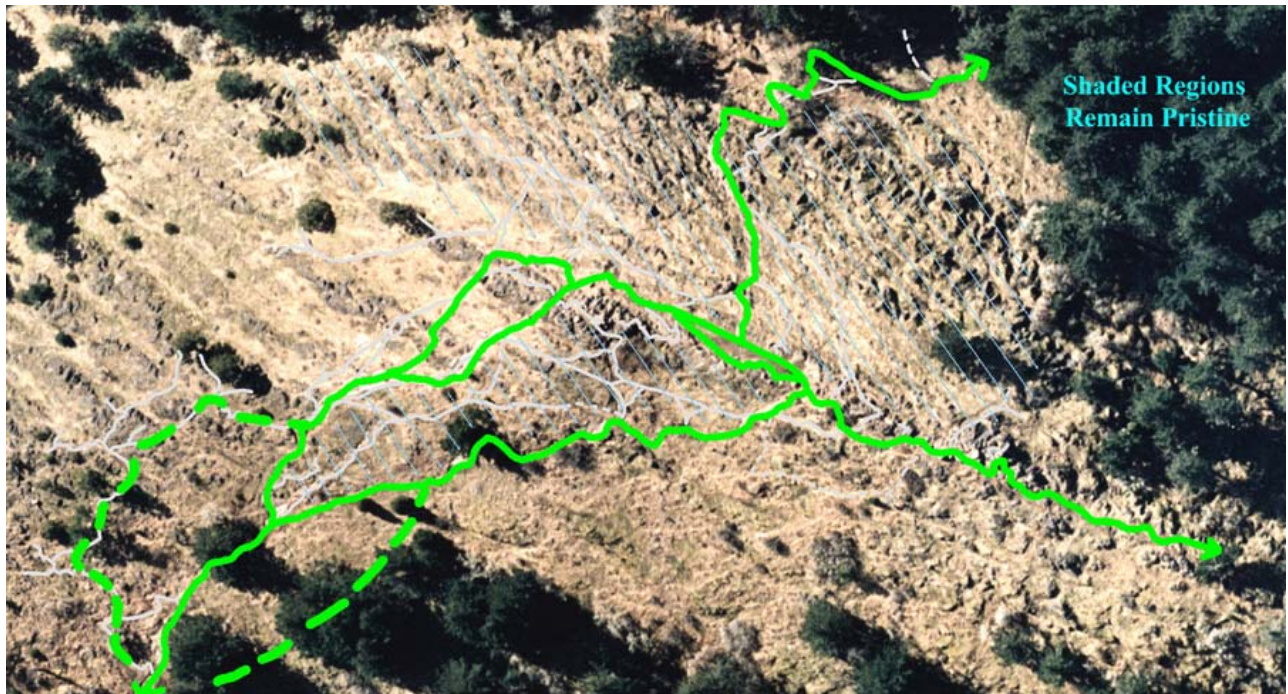
Pristine:

This map depicts the regions of Spencer Butte that would remain pristine if all mitigation techniques were adopted. In other words, the shaded regions do not have official trails and would therefore remain in pristine condition (or regenerate themselves to pristine condition).

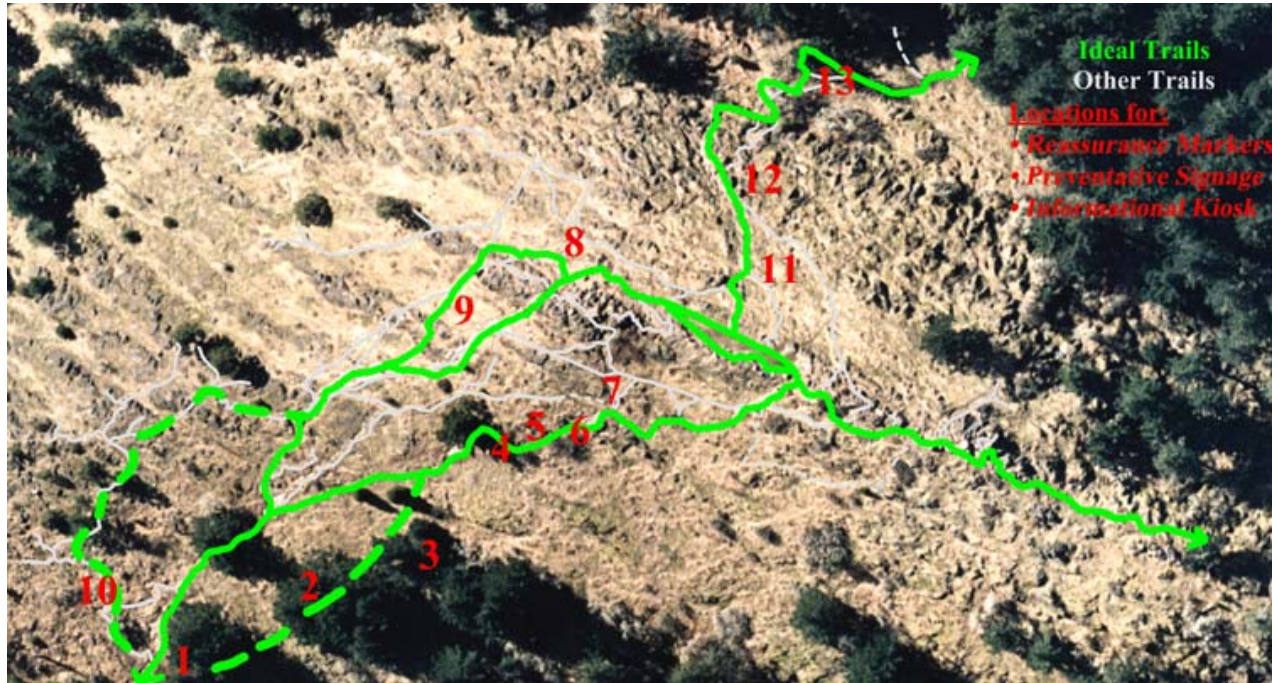
Signage:

This map depicts the numbering system of the potential locations of mitigation efforts such as preventative signage, reassurance markers, and a kiosk. The following section details each location.

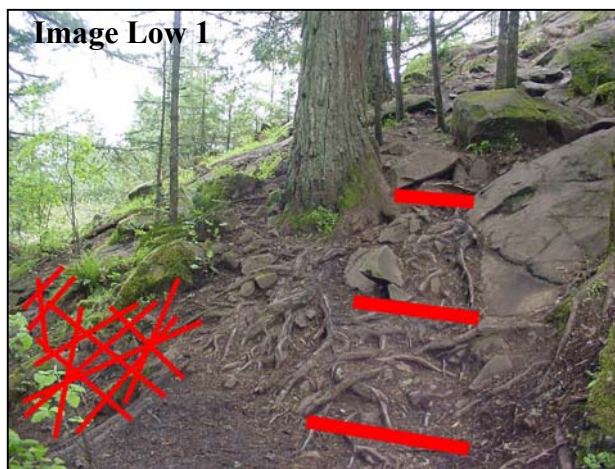
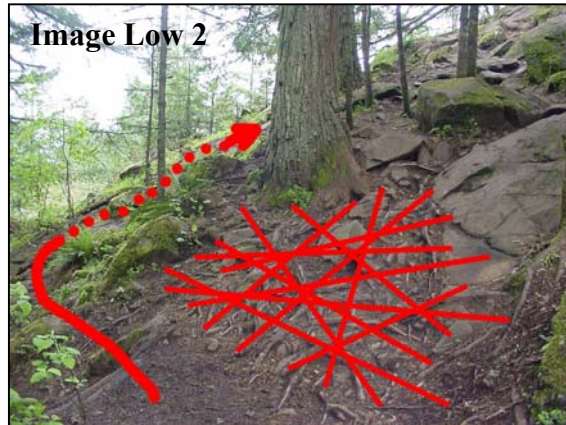
Low East Hot Spot:

The Low East Hot Spot is essentially the place at which hikers are faced with a crucial decision. They must either turn right (north), heading to the East 1 trail, go straight (west), heading up the confusing network located around the East 2 trail, or head up the East 3 trail that rises from the south slope. This is a particularly important mitigation location because it can serve multiple purposes. First, it can tell hikers which way is the best ascent route and where to find this trail. Second, a kiosk can inform hikers about the trail system

Images *Low 1* and *Low 2* show the two best options for directing people to the East 1 trail, the ideal ascent trail. The first option, or *Low 1*, shows steps that rise over the exposed roots of a tree. These steps would guide hikers easily over the roots and toward the kiosk that would send them either onto the East 3 or the East 1 ascent trails. The second option, or *Low 2*, blocks the roots with brushings and directs hikers to the south, around the steep rocky section. This diversion would also lead up to the kiosk but would be slightly longer and less steep than the first option. The *Low 2* option would require some fairly extensive trail work to ensure the stability of this segment of trail.

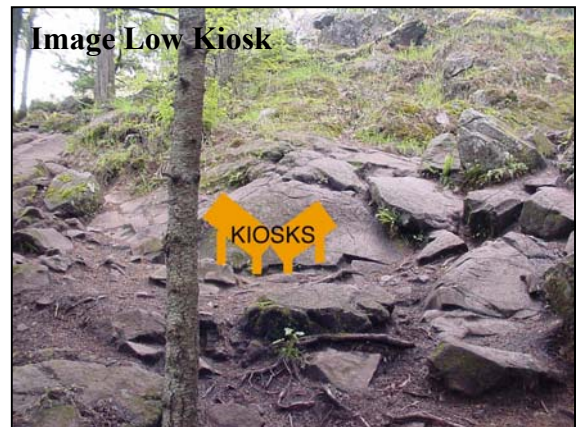
The Low East educational kiosk, depicted in image *Low Kiosk*, is meant to be an informative guide for hikers. The Kiosk would not only be visible from the forested part of the trail, but would also serve as reassurance that hikers were about to enter the rock outcrop area of Spencer Butte. A description and diagram of the Kiosk are located _____.

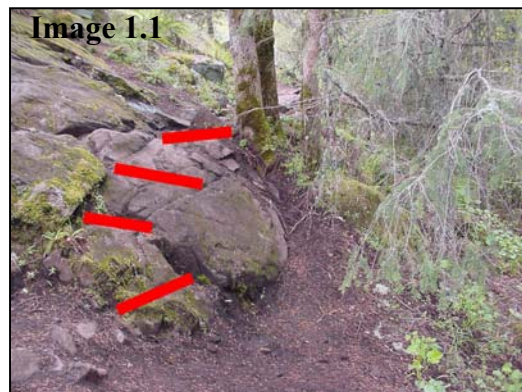
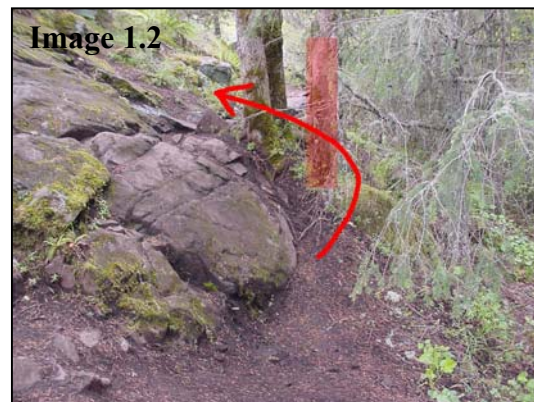
East # 1:

The East 1 trail is potentially an ideal ascent route. It runs low on the eastern slope and is well-worn and would be easily recognizable with a few improvements. There are at least two separate

mitigation actions to be taken here. The first, depicted in image *1.1*, shows the potential for steps running across the ridge of the main rock section of the trail. Easily recognizable steps would

effectively channel hikers onto the main East 1 trail and divert them from East 2, depicted in image 1.3.

Another option to divert hikers from the East 2 trail and onto the East 1 trail is to remove the young Douglas fir to the east of the rocks and send hikers around and back up to the main trail. Image 1.2 shows this option by representing the ideal route as a red line and the tree to be removed as an opaque red box. This option would be substantially more expensive due to the removal of a tree, but would likely serve as a more lasting and recognizable section of trail.

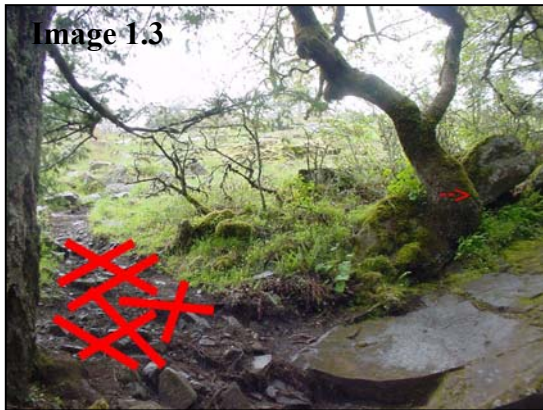
Image 1.3 shows the location at which hikers stray from East 1, the ideal ascent route, onto East 2, a more fragile trail with more potential confusion areas, or “hot spots”. Brushings, potentially in conjunction with preventative signage, could effectively keep people off of this trail and, when combined with steps and possible a reassurance marker, would divert hikers onto the main East 1 trail. The reassurance marker, shown as a red arrow, could be located either on the tree (as it is shown in image 1.3) or on the rocks below. It would direct hikers to the north, onto the main East 1 trail.

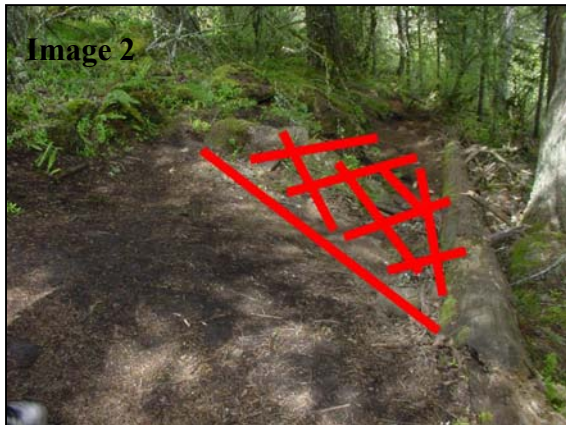
East # 2:

East 2 is a well-worn cut-off from the East 1 trail back down to the forested East trail. Brushings across this trail, shown in image 2, would make it more difficult for hikers to try and work their way over or through the brushings than it would be to stay on the trail that switchbacks to the east trail in the forest. This mitigation option is designed mainly to assist descending hikers in making their way down the trail. Upon reaching this point in a descent route, hikers can easily become confused and head down this steep cutoff instead of continuing down the main trail.

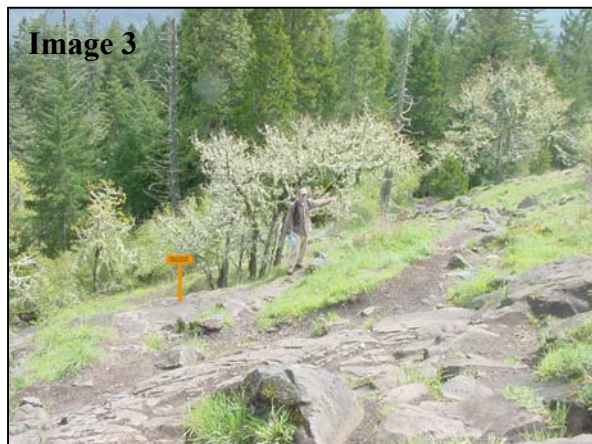
East # 3:

East 3 is another, but more main cutoff hikers can take to the forested main East trail. The preventative signage should explain to hikers that the trail they are about to take is not an official trail and that they would cause harm to the fragile plants if they were to use this unofficial trail. (It could read: “Please Stay on Trail / Fragile Native Habitat”). This mitigation would be directed to those using the East 1 trail as their descent route. As a result of less traffic on this cutoff, native vegetation would slowly return under optimal circumstances. This positive feedback is possible anywhere trampling pressure is reduced. Hopefully, native plants would move in to previously disturbed areas before invasive species could take hold. Image 3 shows the location of this sign.

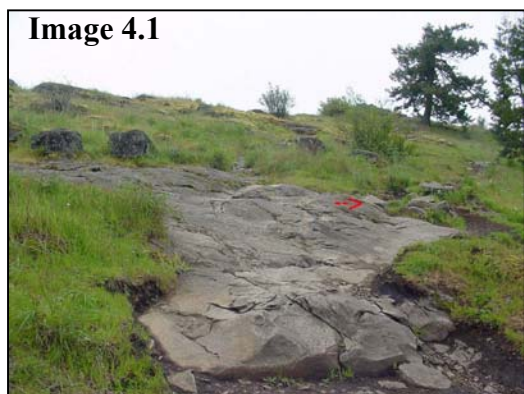
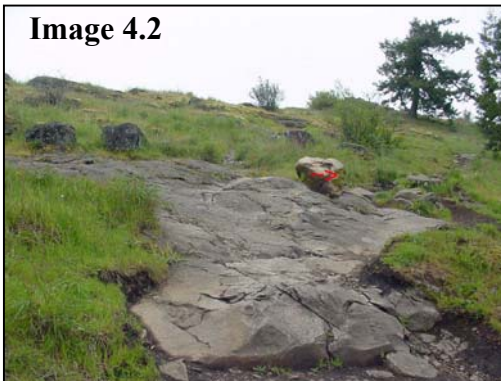
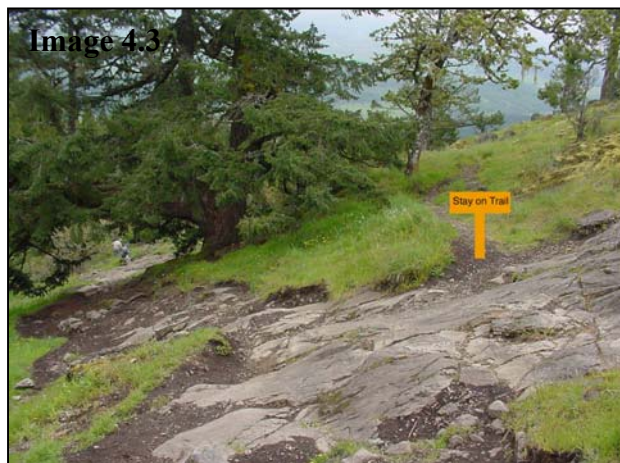
East # 4:

The East 4 Hot Spot is of extreme importance to both ascent as well as descent routes. Up to four unofficial trails converge at this point, making it extremely easy for hikers to become confused. Image 4.1 shows the ascent route reassurance marker as a red arrow. The arrow clearly shows hikers the direction of the official trail. Image 4.2 is another option for ascent reassurance. A rock (the rock pictured in Image 7, for example) could be moved so that a reassurance arrow could be located on it and made more visible than it would be either on a sign or on the ground itself. The rock

mentioned will be potentially removed as a series of steps are constructed in Image 7.

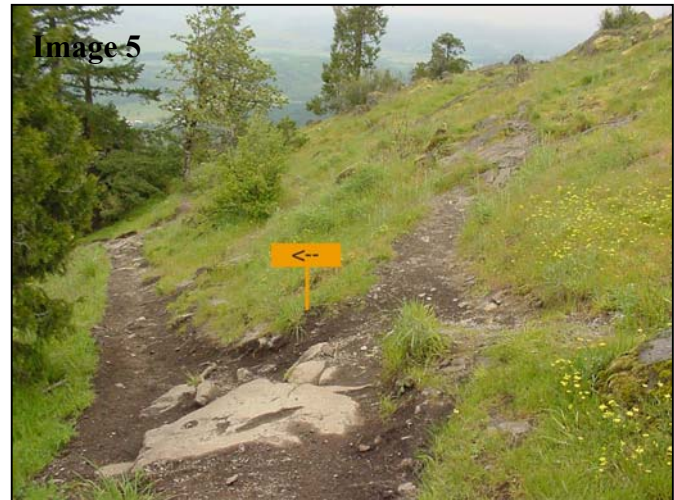
The East 5 Hot Spot is a descent reassurance marker. An arrow that directs hikers away from the unofficial trails and onto the ideal trail: East 1. The benefits of this marker are that an unobtrusive arrow could effectively keep many hikers off of the elaborate and confusing network of trails that blanket the east slope of Spencer Butte. Image 5 depicts the marker as an arrow on a small orange sign. Based on the responses of hikers to Survey questions we suspect that the majority of Spencer Butte’s users would respond positively to reassurance. As a result, hikers would be willing to limit where they walked or ran as long as the suggested trails were clearly marked. The reassurance shown in image 5 would help descending hikers stay on East 1 and off of the rest of the fragile eastern slope of Spencer Butte.

An additional measure could be taken at this location to reduce the volume of hikers that leave the ideal East 1 route. Revegetation of the East 2 trail could make it even more apparent to hikers that East 1 is the main trail. This revegetation could either be accomplished via propagation of native plants or simply by allowing the region to revegetate itself.

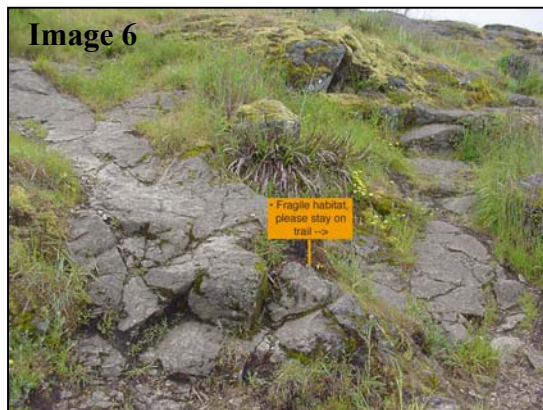
East # 6:

The East 6 Hot Spot is a place that many hikers, on their ascent route, cut off a chunk of the official trail because the summit rocks are clearly visible. There are actually two or three various routes to the summit rocks from this point but one reassurance marker would keep most of these off-trail hikers on the right track. The official trail reaches the summit rocks very soon and this is visible once hikers notice the official trail’s route. This is made clear by the insertion of a reassurance marker pointing in the direction of the East 1 trail. Image 6 depicts the location of an arrow pointing north, toward the ideal

ascent route. Fragile moss mats and lichen habitat are vulnerable to trampling pressure when hikers go off-trail and cut directly up toward the summit rocks.

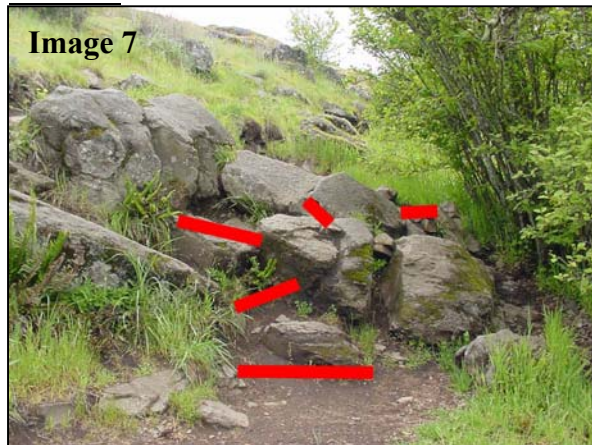
Image 7

East 7 is a potential location of steps. The rock pictured in image 7 is a relatively large drop, making the degree of difficulty on this portion of trail much greater than it needs to be. Steps would accomplish two things. First, they would make the summit of Spencer Butte accessible to beginners. Second, steps would serve as reassurance markers. Once hikers see steps, it becomes very obvious that they are on the right track. Although this mitigation option is relatively expensive, it would be very effective in keeping hikers from excessively trampling fragile

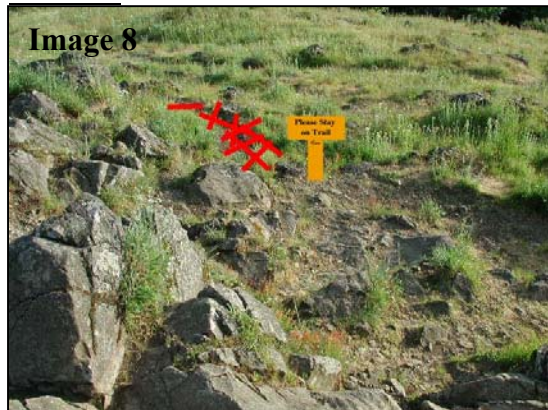
Image 8

The East 8 Hot Spot is particularly important because it is the juncture at which hikers begin their descent. By encouraging hikers to cross the north-south running main spine of rock, the upper south slope is protected. With patches of rare castilea grass and fragile moss mats and lichen habitat, the upper south slope is an especially pristine region that could potentially be kept that way. This region is also potential habitat for migrating butterfly populations. Preventative signage showing hikers the point at which they should head over the spine of rocks to the

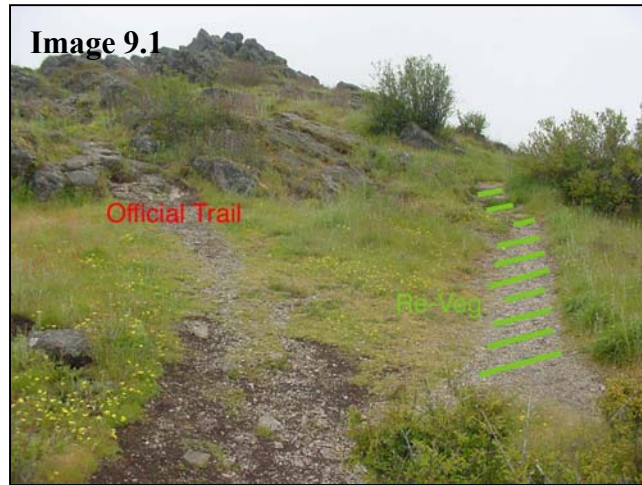
East # 9 Hot Spot:

This is another extremely critical area of Spencer Butte. For hikers making their ascent to the summit, there are at least two unofficial trails they might end up on. Image 9.1 depicts this confusion and shows which trail should be made official so as to lead hikers over the rocky spine or to the south side of the summit rocks. This diversion can only be successful with revegetation and preventative signage. Coconut husk-fiber mats to facilitate the re-generation of topsoil and an active revegetation regime would be effective in the re-establishment of native flora. The regions that should be revegetated

are shown in image 9.1 in green.

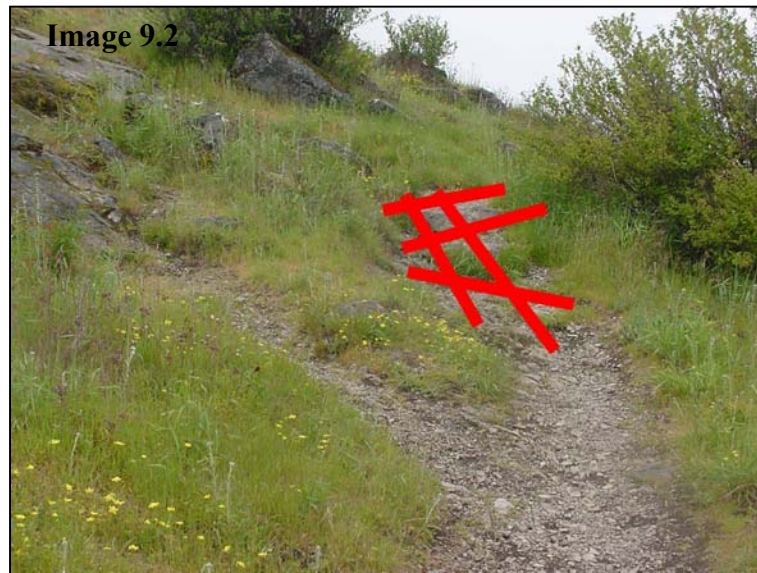
Brushings might also help in the short-term to prevent hikers from heading north on the unofficial trails. Image 9.2 depicts these brushings. Complimenting the revegetation efforts would be two signs. One temporary sign would inform and make obvious the revegetation efforts. (Sign could read: "Active Revegetation of Native Plants / Please Keep Out"). The second permanent sign would direct hikers away from the confusing network of trails that head parallel to the rocky spine and run north. This sign should also explain to hikers the fragility of the habitat

they would be trampling if they go off-trail. (Sign could read: "Fragile Native Habitat / Please Stay on Trail").

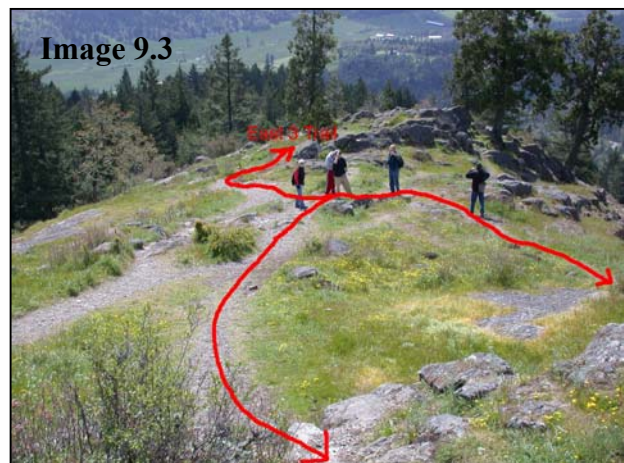
Image 9.3 shows, from the summit rocks, the braided trail network located at East # 9. This image shows the ideal route hikers should take in red. The mitigation described for images 9.1 and 9.2 would enable this route to become the main route.

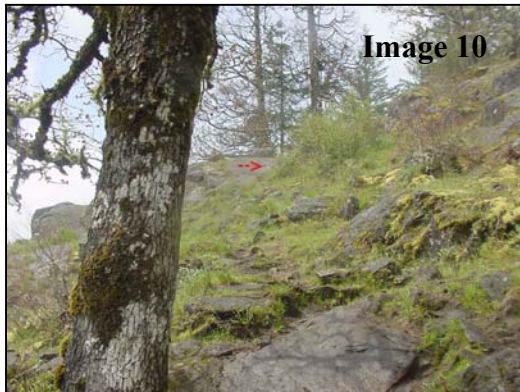
East # 10:

The East 10 reassurance marker, shown as a red arrow, would serve to help ascending hikers locate the trail from relatively far away. For example, a hiker coming out of the Low East Hot Spot might find it difficult to locate the trail. If this hiker were able to see a reassurance arrow from relatively low on their ascent route, he or she would most likely make his or her way toward it. Once they reach this point, it would be easier to locate the rest of the trail. The lower sections of the East 3 trail are the most confusing in terms of identification. In other words, once hikers find the

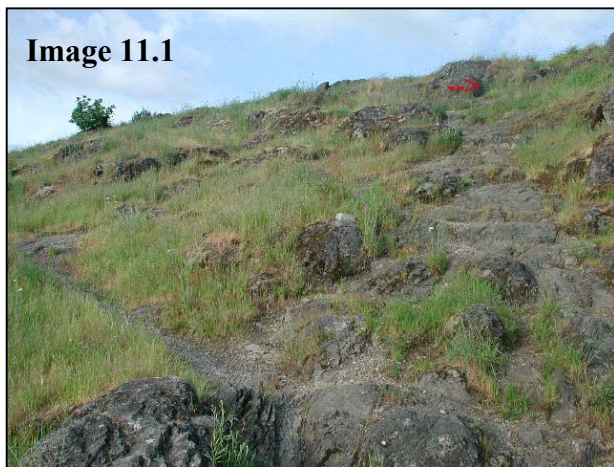
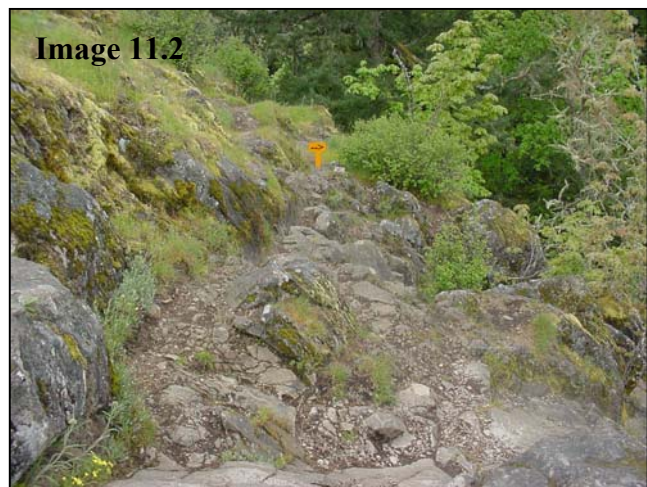
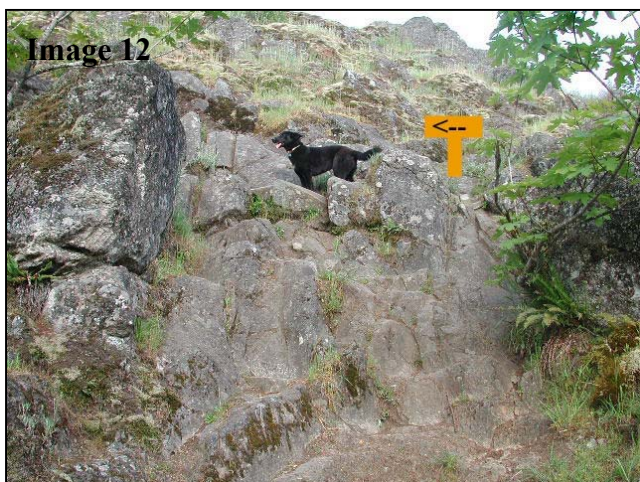
West #11:

West 11 is a location at which ascending hikers could use reassurance regarding the direction they should head. There is a large rock that makes for a good reference point. A reassurance marker here would make a big difference in channeling hikers straight to the gravel area and away from the fragile and steep moss mats and wildflower beds of the rest of the west slope.

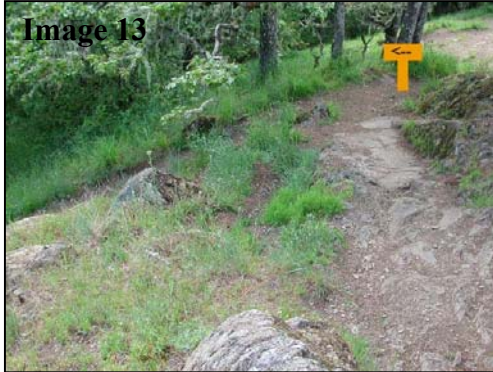
West #13:

Image 13 depicts a reassurance marker meant to be seen by ascending hikers. It simply shows them that the trail heads north, up the already scoured rocks, not south, toward a fragile moss mat and lichen habitat.
